City of Chicopee

RE: City Council Minutes from the May 27, 2016 Special Meeting

Dietz and Company Architects, Inc. is pleased to present this Historic Structure Report (HSR) and the results of the team's efforts to document the history and physical condition of Chicopee City Hall. The overall purpose of any Historic Structure Report is to guide future rehabilitation, restoration, and preservation work for the subject structure. The 'Historical Information' section documents the history of the building and its changes over time. The 'System Description and Observations' portion of the report summarizes the survey, analysis and recommendations for the building.

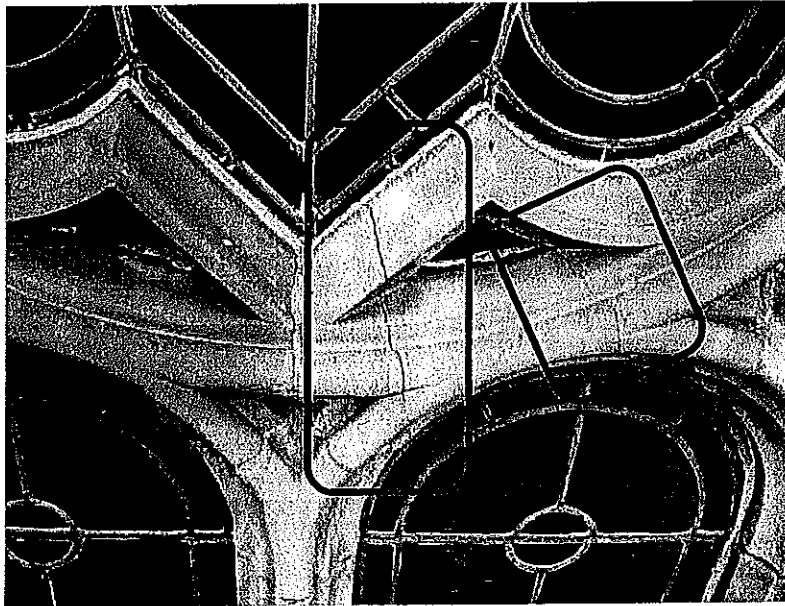
33. Photo 33 – View of the cracked stone tracery on the North elevation.

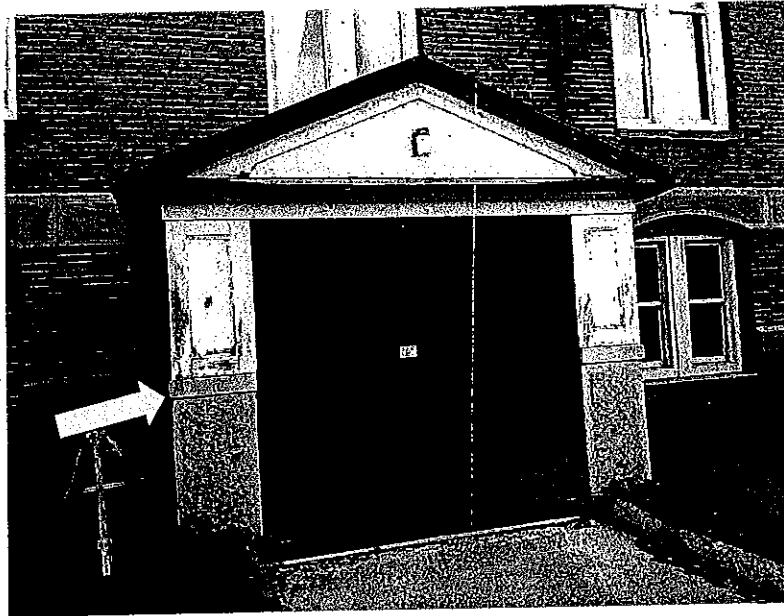
34. Photo 34 – On the North elevation, at the basement level vestibule, paint is peeling on the wood trim components resulting in deteriorated wood at the corners of the trim. The stone water table, where noted, has spalled.

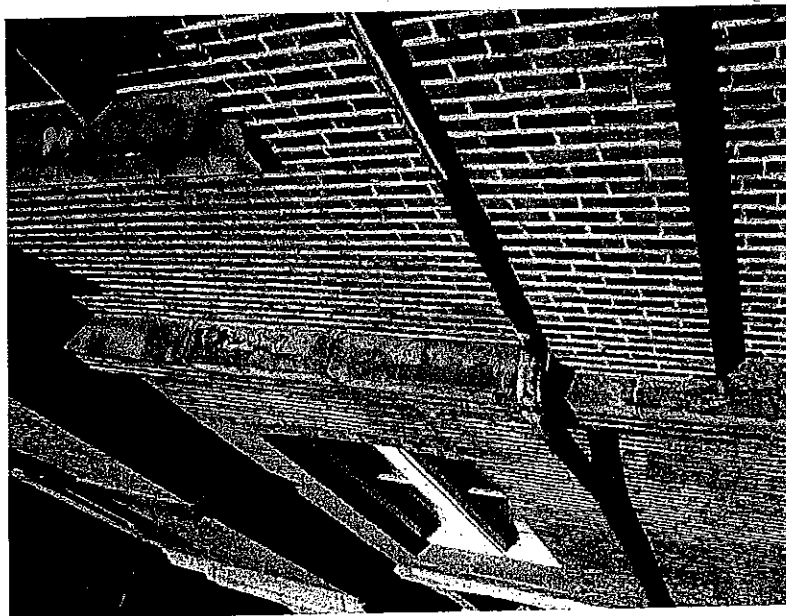
35. Photo 35 – View of the rectangular water table on the South elevation, while similar to the North elevation, is in poor condition on this elevation.

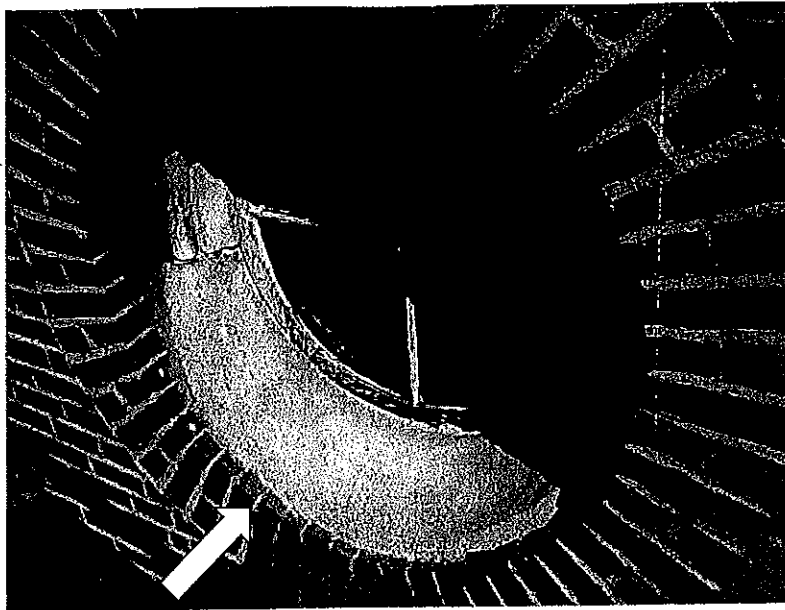
36. Photo 36 – View of the round window on the gable elevation of the South elevation. Unlike the West elevation, the mortar wash is not extended to the leading edge resulting in open brick mortar cross joints.

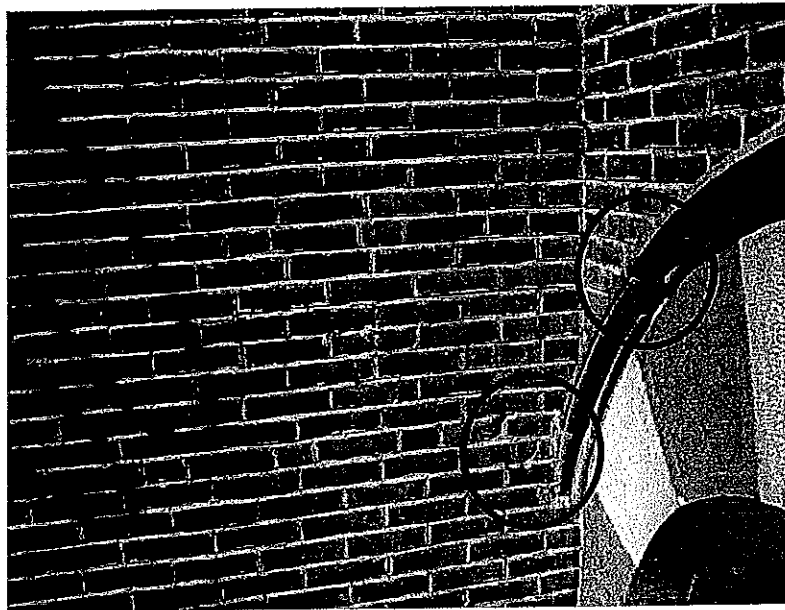
37. Photo 37 – On the gable elevation of the South elevation, the arched window spring point is buried in the East elevation of the Tower. The stone arch trim water table has spalled where noted.

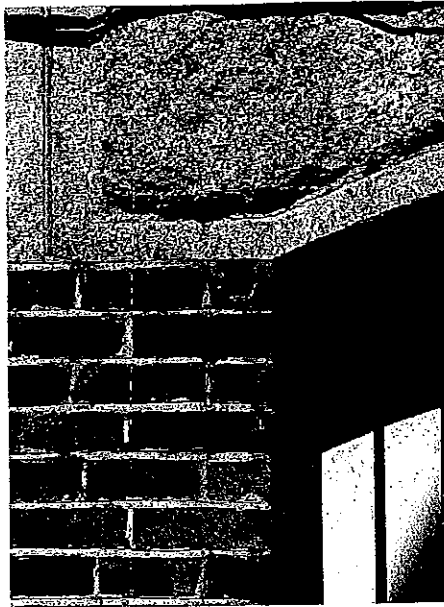
40. Photo 40 – View of the hole in the brick at an abandoned sleeve location. Within this same bay, cracked mortar joints were observed.

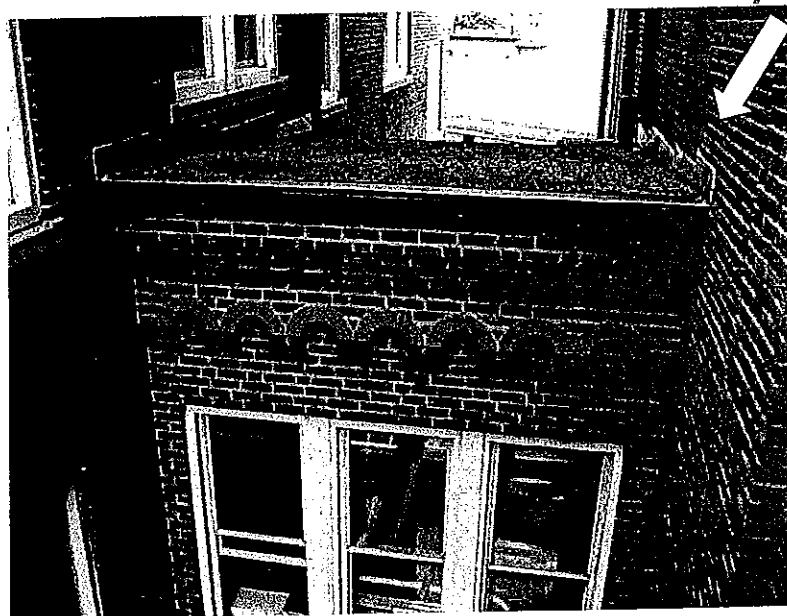
43. Photo 43 -- View of the Bridge roof and partial view of the North elevation. At the locations noted, the mortar joints above the step flashing have some cracks in an area that appears to have been previously repaired. Also, the sealant joints above the stepped reglet counter-flashing have several applications of sealant and are in poor condition.

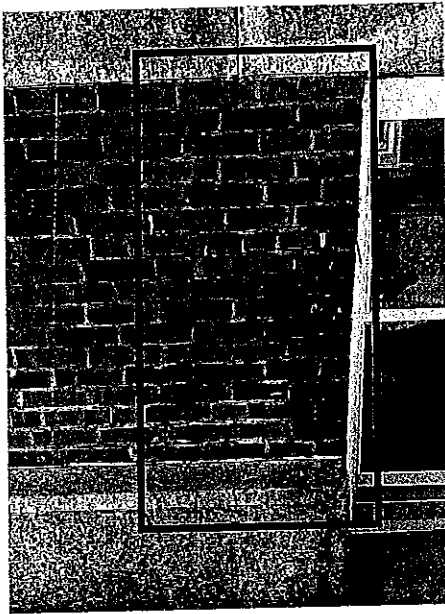
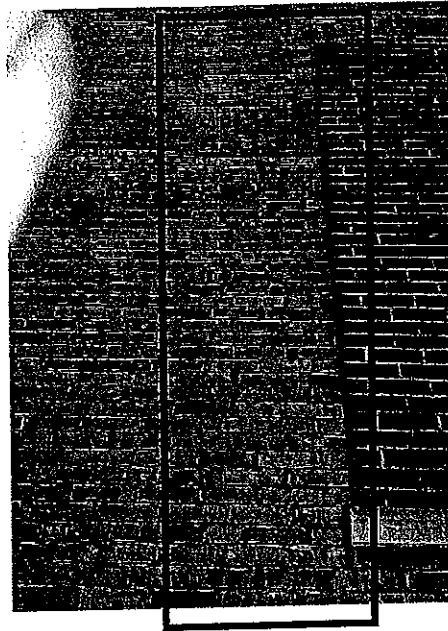
44. Photos 44a & 44b – View of a step crack in the basement level brick on the East elevation, Southeast corner. The step crack has resulted in cracked brick and open mortar joints. The crack continues through the mortar joint at the granite water table, continues up the main level and terminates near the head of the window infill. In addition to the step crack, open and cracked mortar joints were observed adjacent to the window. This condition was observed at the basement level and around each of the window openings.

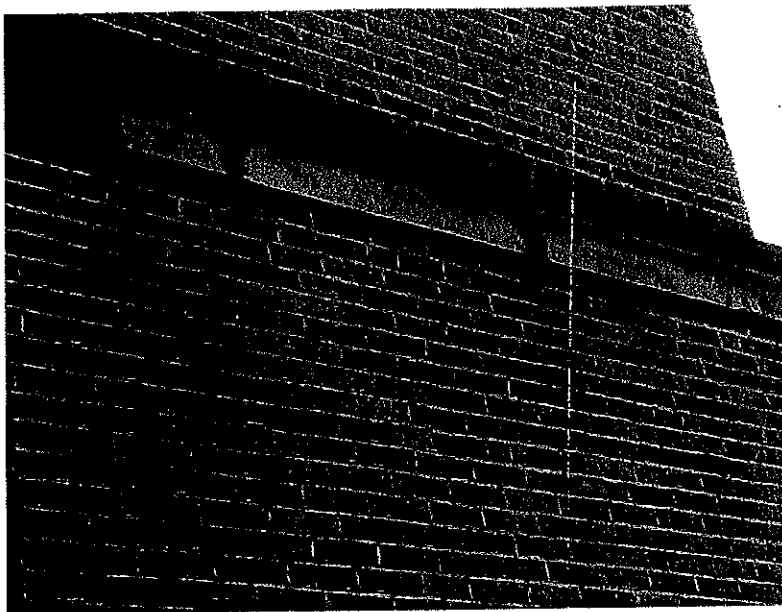
46. Photo 46 – The sandstone water table above the granite base continue from the main West elevation has delaminated, spalled, weathered, and cracked.

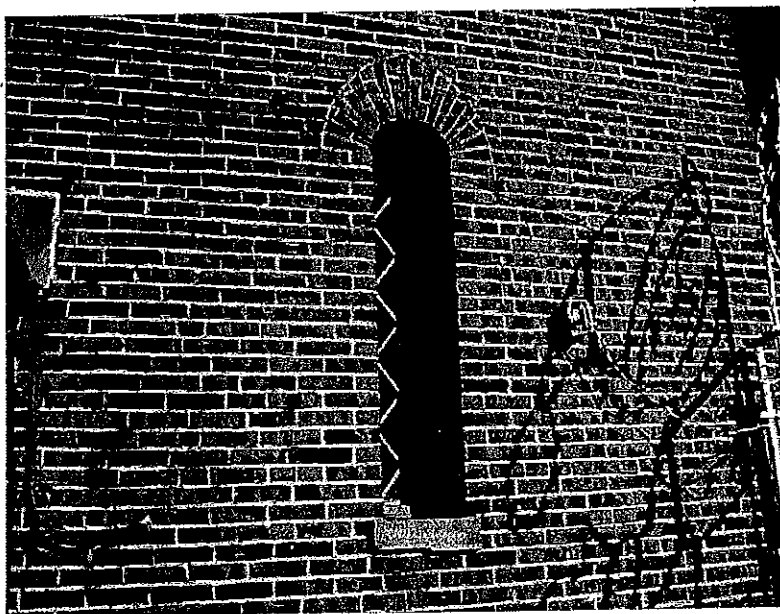
47. Photo 47 – The sandstone sill at the intermediate Tower window has spalled. The wood trim at each of the sliver windows on the Tower's elevation has peeled exposing the wood frame and brick mold trim to weather.

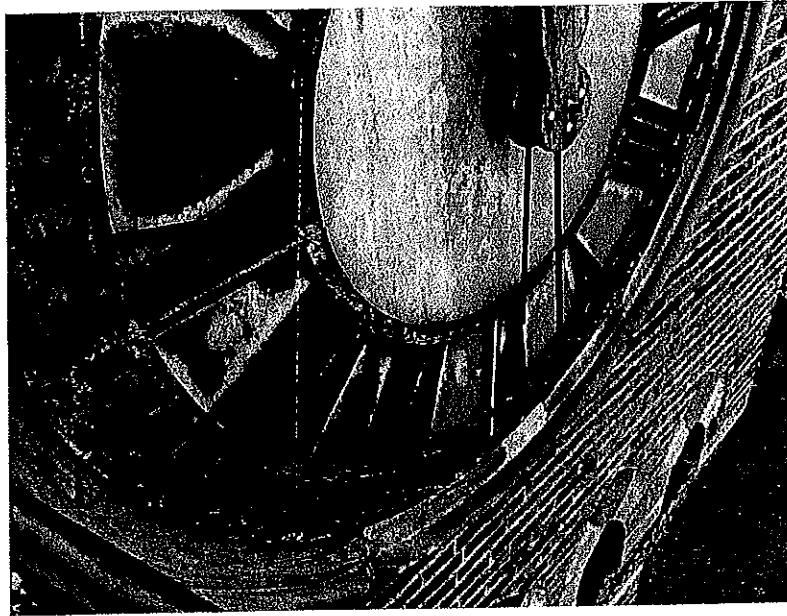
48. Photo 48 – Partial view of the clock and curved stone surround on the West Tower elevation. The lower stones are weathered, cracked, and spalled. The paint on the iron clock face has deteriorated exposing the iron to further deterioration. The iron contains surface rust and is pitted. The opal glass appears intact although a layer of environmental soiling was observed. The wood hands on iron rods have deteriorated. Similar defects were observed on the East elevation clock.

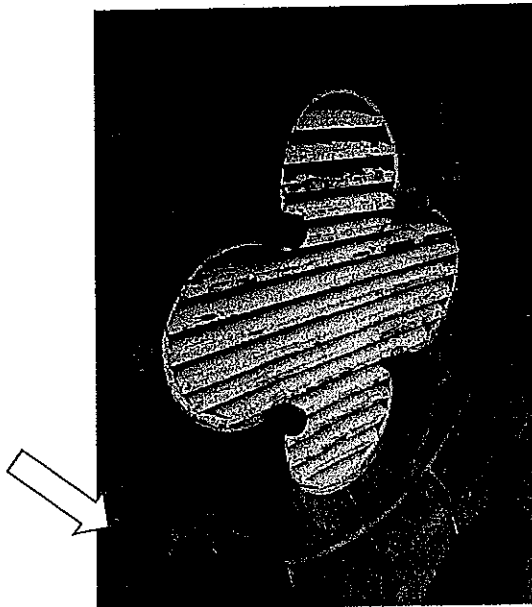
49. Photo 49 – View of the rose louver on the West Tower elevation. The area denoted indicates delaminated stone. The louver is not resistant to wind driven rain and is there is evidence of water infiltration on the interior. The paint on the louver has peeled exposing the metal to further deterioration. The perimeter sealant has lost cohesion and is in a failed condition.

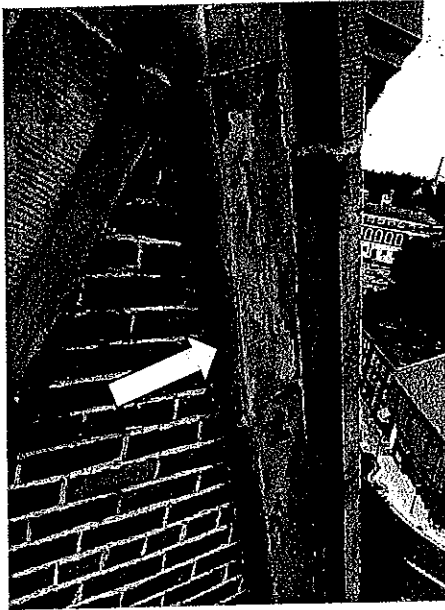
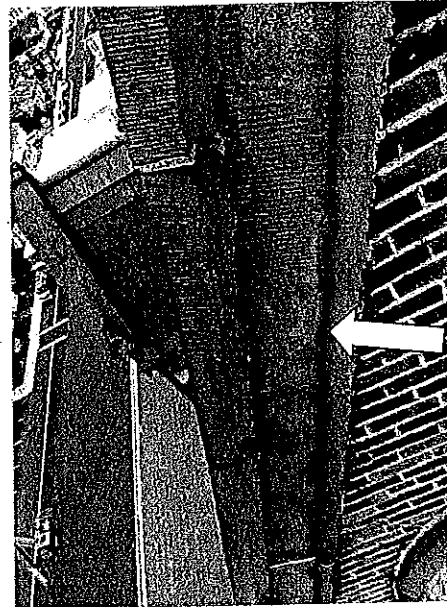
50. Photos 50a & 50b – Views of the weathered facing stones below the coping stones that should be removed and replaced. The stones in the left photos are primarily along the South rake while the right photo is along the North rake. The mortar cross joints for the coping stones are typically cracked and open.

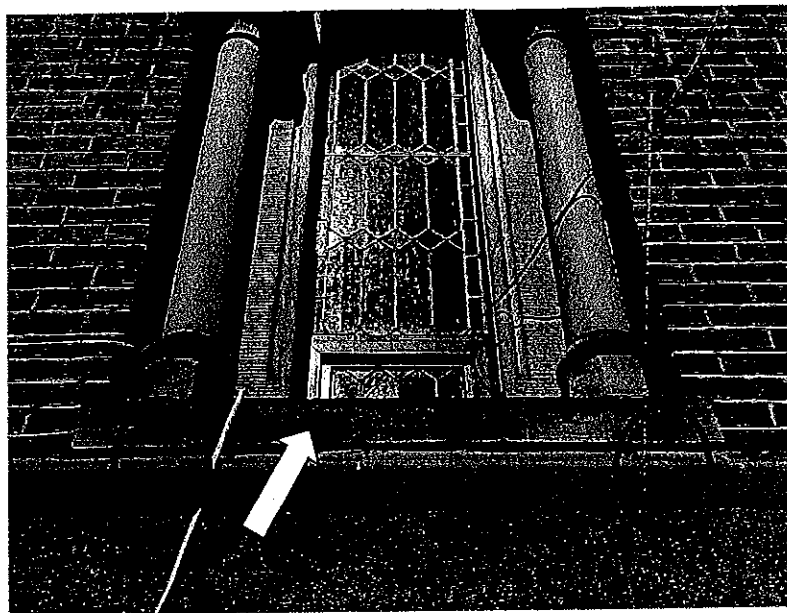
52. Photo 52 – View of the cracked window sill and water table on the South Tower, main level.

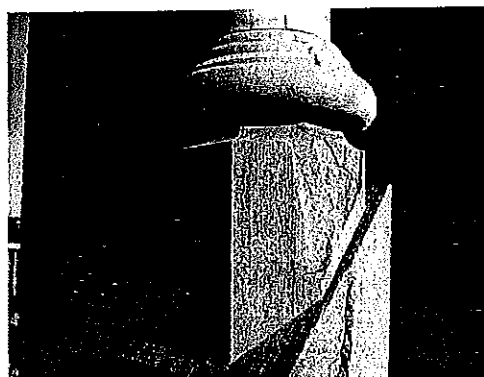
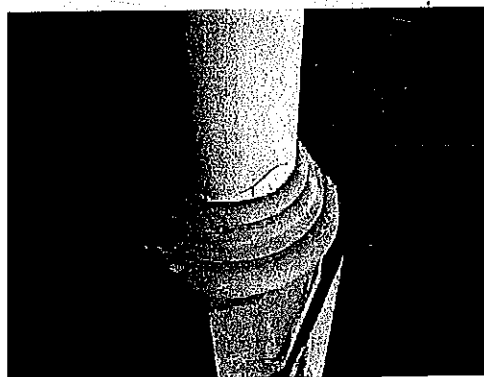
53. Photos 53a, 53b, & 53c – Views of the amortism and column shaft stones on the Tower South elevation.

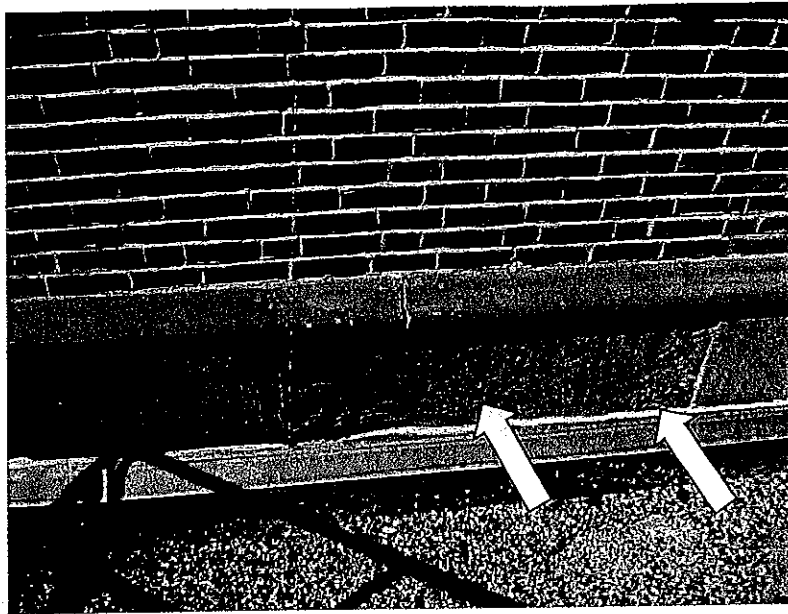
55. Photo 55 – View of the delaminated stone water table above the basement entrance roof. The flashings appear to be in serviceable condition however, the sealant has failed.

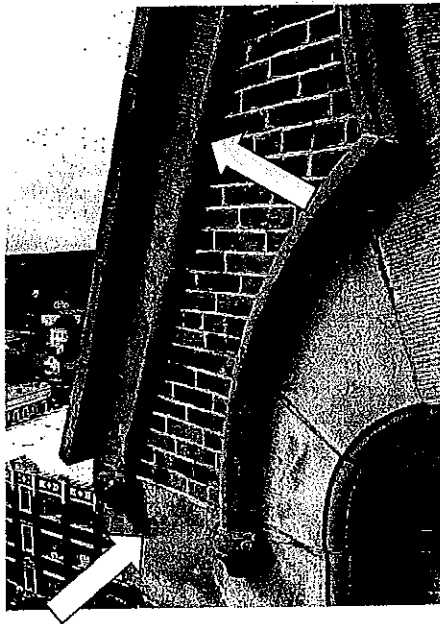
56. Photo 56 – View of the delaminated stone banding and florette accent on the East Tower elevation.

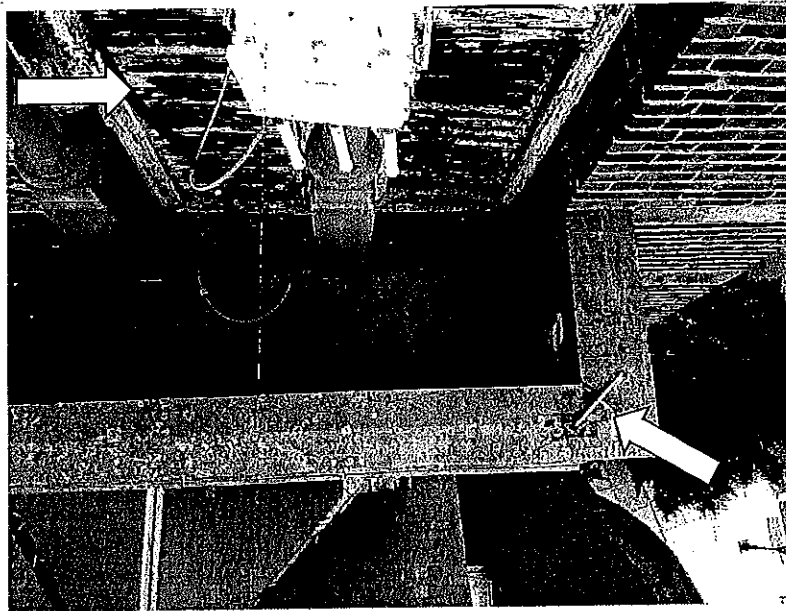
57. Photo 57 – View of the Tower North balcony. Note the stainless steel pin at the corner and the rust on the louvers where the paint has deteriorated.

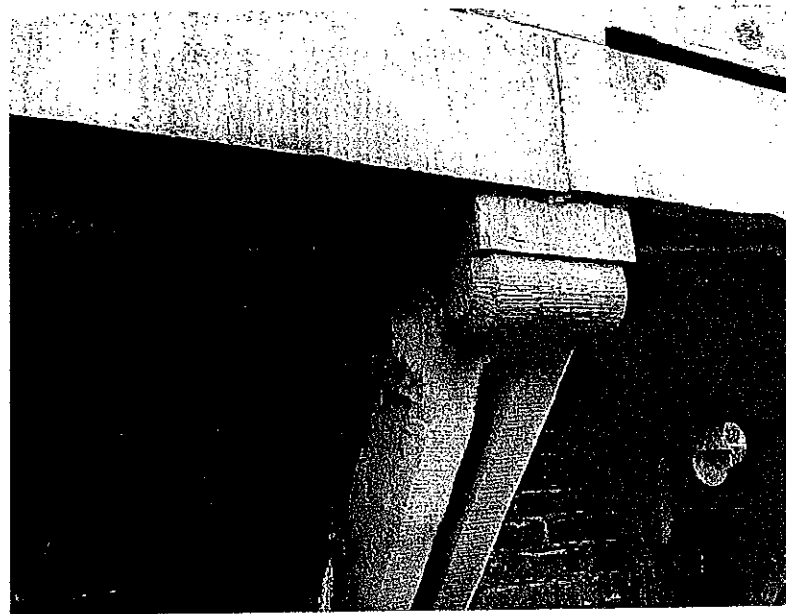
58. Photo 58 – View of the stone brackets beneath the balcony. Note the efflorescence on the underside of the balcony platform and the eroded bracket outrigger. These items are evidence of water infiltration and stone deterioration.

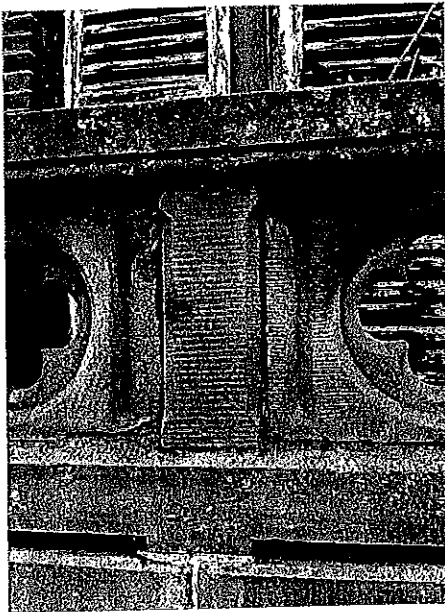
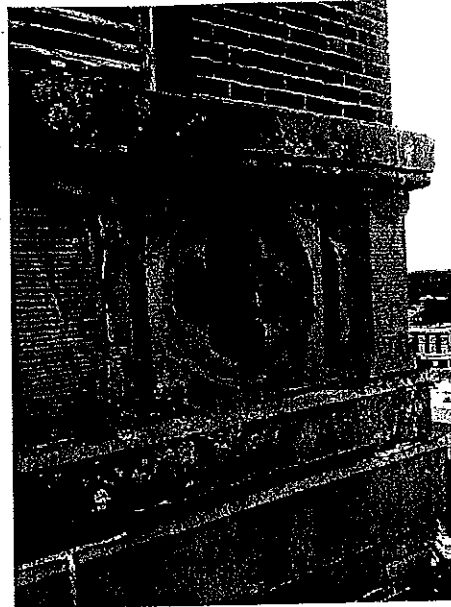
59. Photos 59a and 59b – Views of the stone balcony post, rails, and panels. Lichen growth was observed on the face of various stone components. Many of the rail components including the west rail panel in the right photo are cracked, delaminated, and spalled.

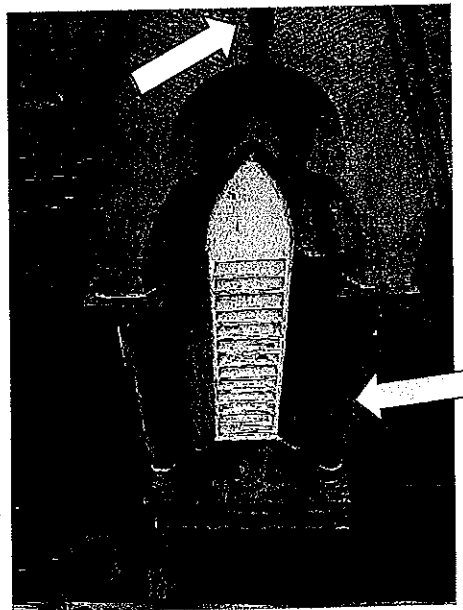
60. Photo 60 – View of the North Tower dormer elevation. The gable stone is cracked at a ferrous metal pin. The stone column on the right (West) side is cracked. Also, the stone mortar joints have deteriorated and the paint has peeled from the louver. The louvers are not resistant to wind driven rain and water infiltration from the louvers was observed on the interior.

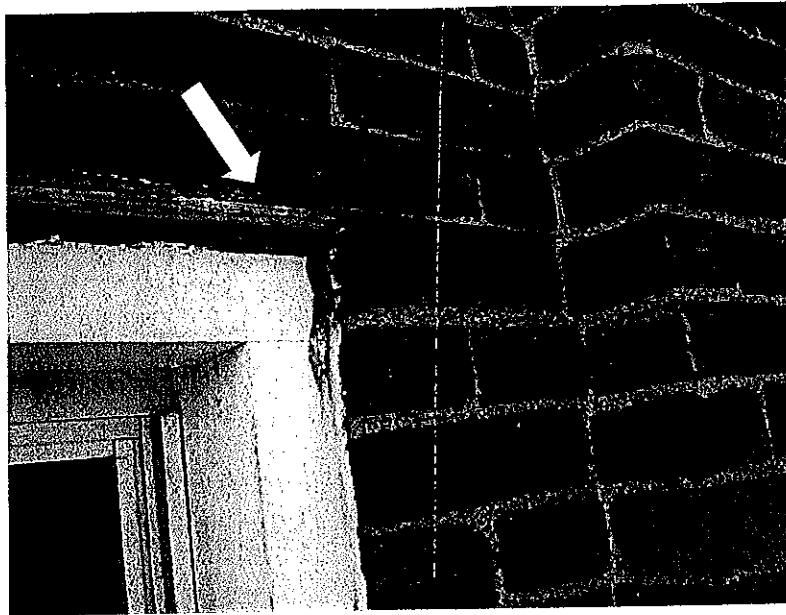
67. Photo 67 – Enlarged view of a steel lintel and bearing on the North Annex elevation. There is no visible drip edge or through-wall flashing at this location or the other locations observed. Most of the lintels observed were rusted but were not deflected. Also, most of the lintel bearings were buried within the mortar.

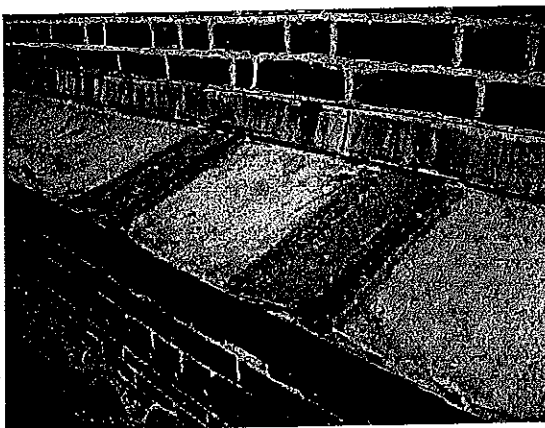
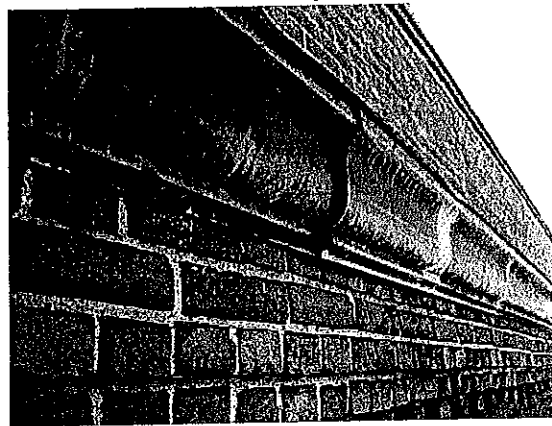
68. Photos 68a and 68b – View of open solder seams at the copper cornice. The cornice is comprised of three pieces; the ogee fascia, the cap, and the counter flashing at the parapet. The copper appears original to the 1929 building.

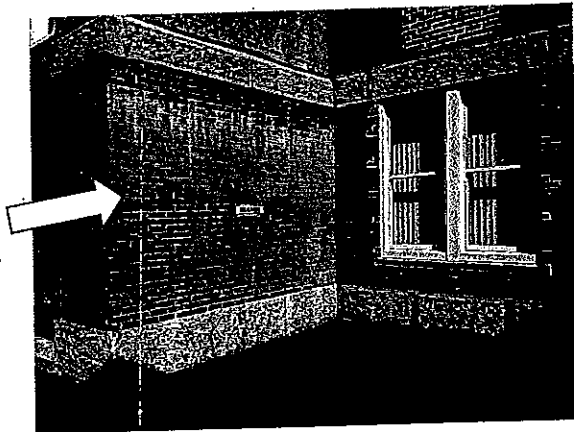
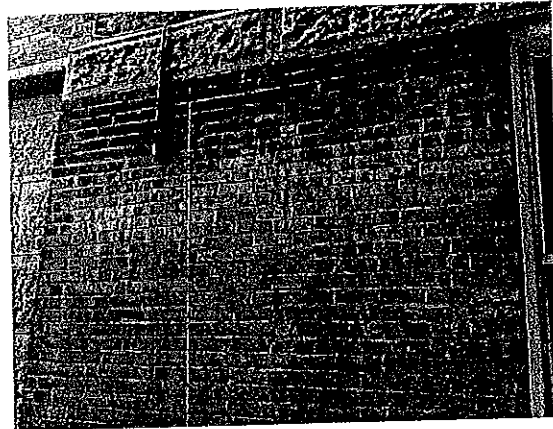
69. Photos 69a and 69b – View of soiling observed on the brick on the Annex South elevation (left photo) and Annex West elevation (right photo).

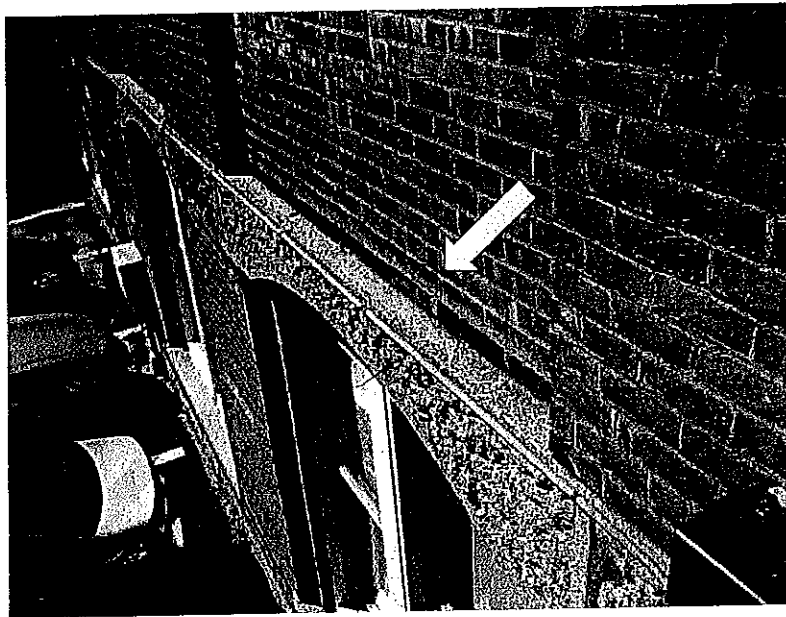
76. Photo 85 – View of the moisture stained brick above the arched cast stone on the East Annex elevation. This condition was observed at each bay along the elevation. The mortar joints between the cast stone water table pieces have cracked and are open.

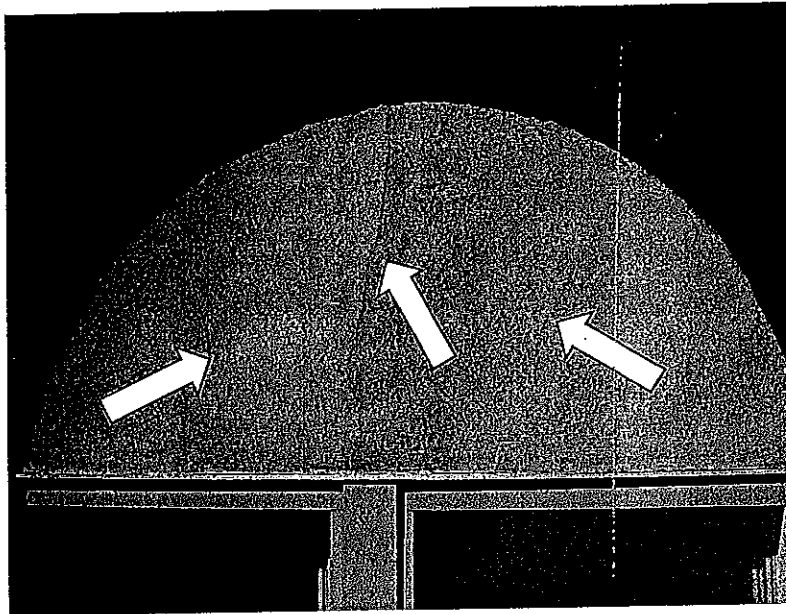
77. Photo 77 -- View of the stucco arched panel above the Annex East elevation fourth level windows. There are open joints between the stucco and the brick in addition to cracks within the surface of the stucco.

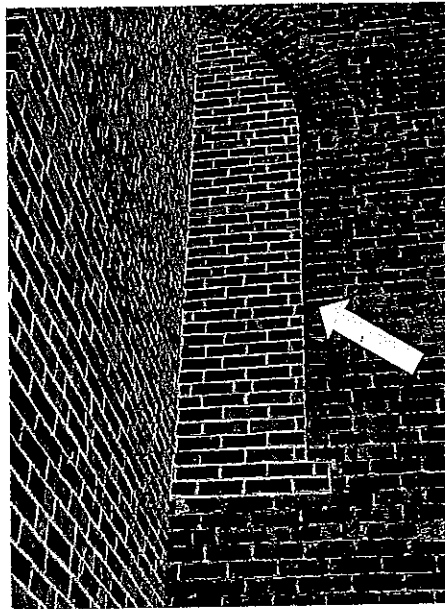
79. Photo 79 -- View of the brick infilled window opening adjacent to the vertical duct shaft on the South Annex elevation. The mortar joint along the infill and the original brick have deteriorated. The infill brick is not keyed into the existing masonry.

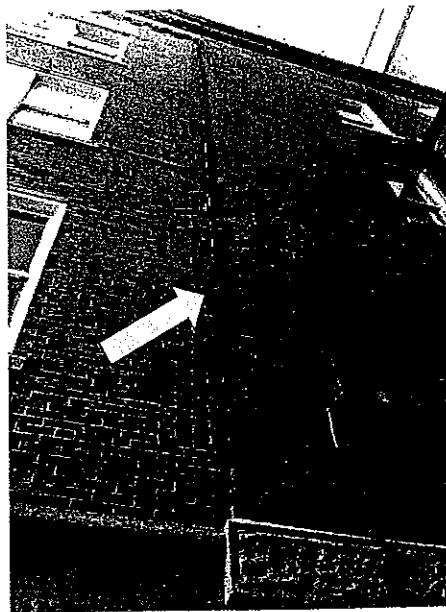
80. Photo 80 -- View of the projecting brick transition on the West Annex elevation. The brick along the transition is soiled and spalled in many locations. The mortar joint between along the transition has cracked and is open.

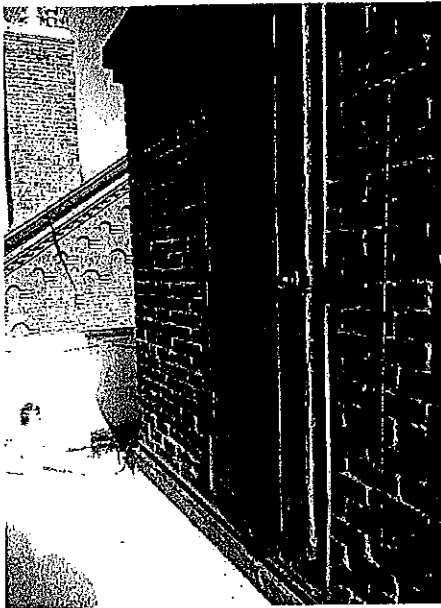
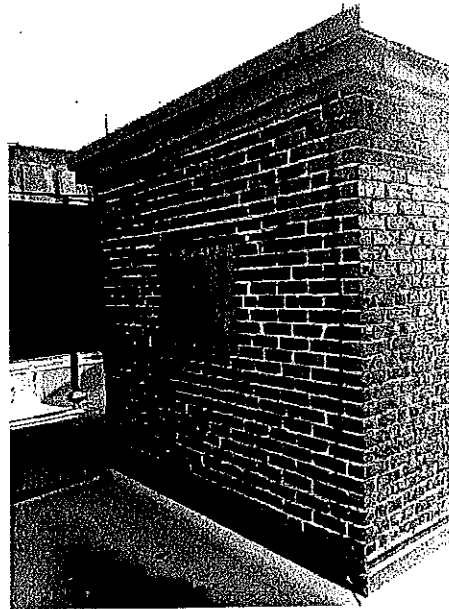
81. Photos 81a and 81b – Views of the Annex high roof elevator penthouse. The brick, while serviceable has weathered and the mortar joints have eroded and others are cracked or missing. The steel door is rusted and is difficult to open. The windows appear to be original and have rust on the steel frame.

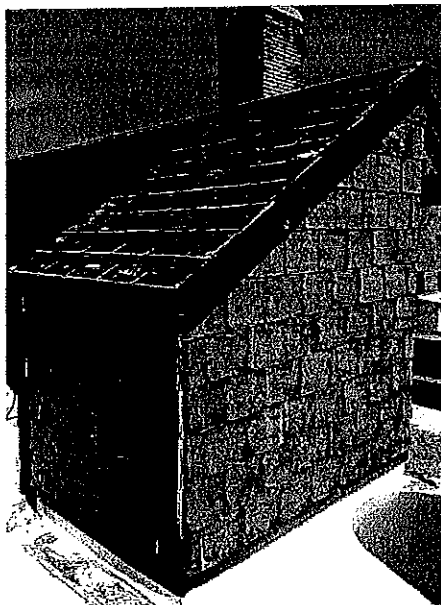
82. Photos 82a and 82b – Views of the Annex high roof stair penthouse. The walls and roof are lined with asbestos tile shingles as confirmed by the environmental report. There are loose and missing shingles.

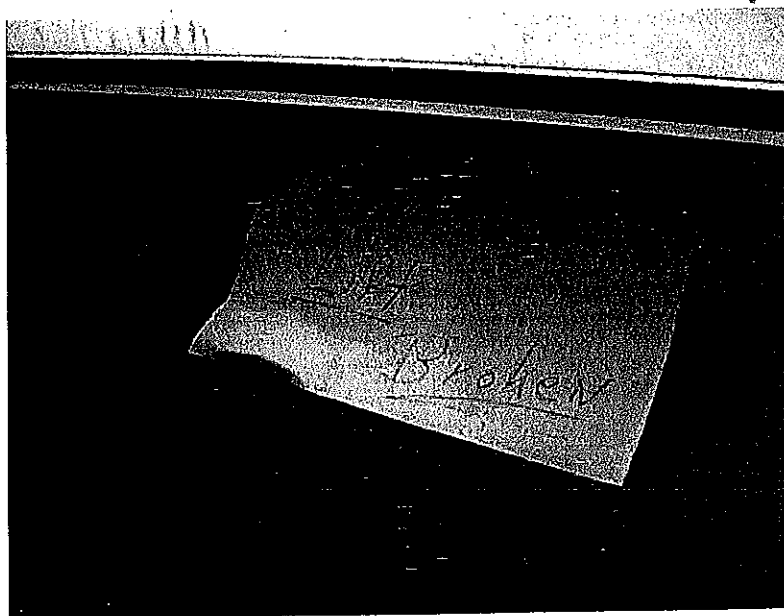
84. Photo 84 – One of the windows overlooking the Annex two story low roof from the Southwest stair was broken.

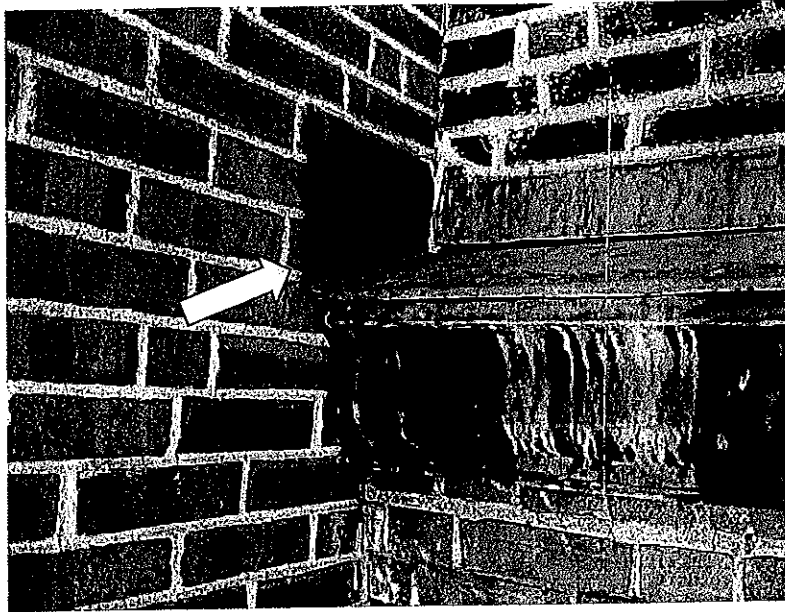
92. Photo 92 -- View of the cracked copper cornice flashing where the two story low roof meets the rising wall along the East Annex elevation.

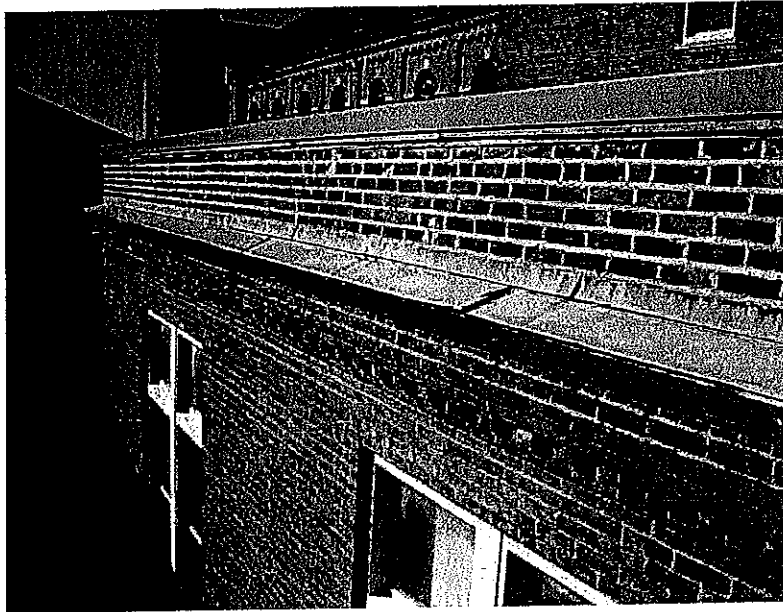
93. Photo 93 – View of the Annex parapet high roof cornice flashing abutting the rising duct shaft. Note the flashing seams against the brick are open to water infiltration. Sealant has been applied to the inside corner.

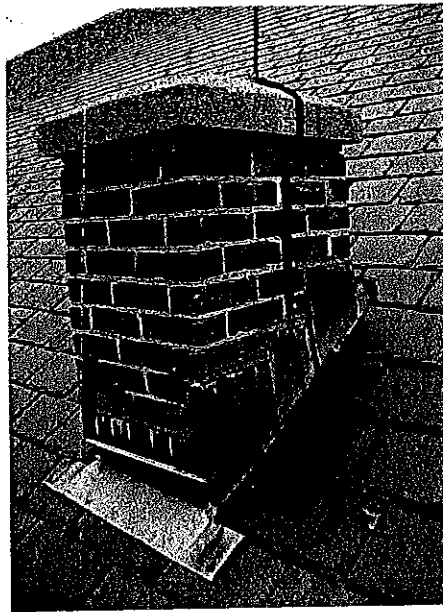
96. Photos 96a and 96b – Views of the historic chimney at the Southeast end of the Old City Hall roof. Some areas of the brick appear to have been repaired while other areas, particularly near the cap. The mortar joints on these areas are weathered, cracked and require repointing. The cap is cracked and the sheet metal flashing on top is not secured to the cap.

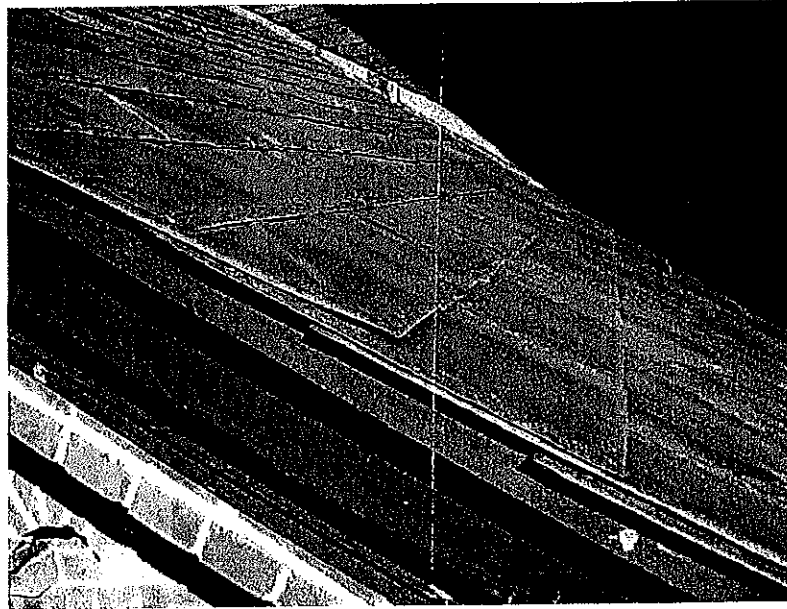
98. Photo 98 – View looking West along the South elevation of the Old City Hall slate roof. The slate shingle covering was in a serviceable condition. In addition to chipped slates, numerous bib flashings were observed.

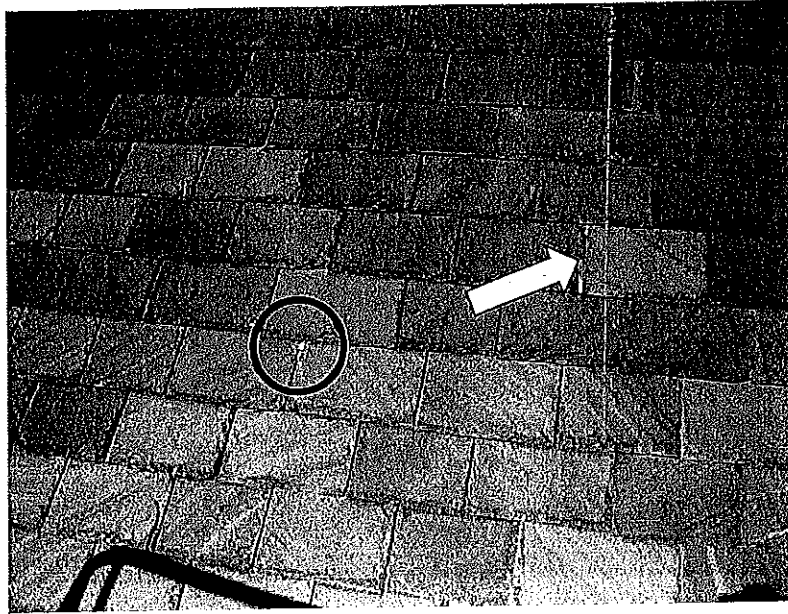
100. Photo 100 – On the South elevation, a broken slate provided information on the type and location of the nails to fasten the slate. The nails observed were copper and were set flush with the top of the slate within the nail depression.

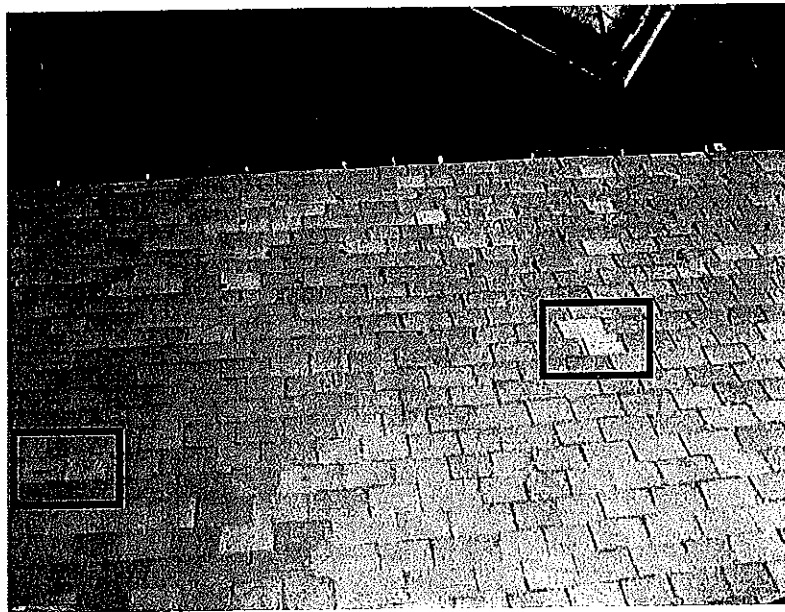
103. Photo 103 – View of the South gable roof. The loose slate abutting the ridge are denoted with the arrow and the slate with the missing Dutchmen nail flashing straps are captured in the rectangle. Both of these same condition were observed along the main roof ridge, the North gable roof, and the Tower gable roof.

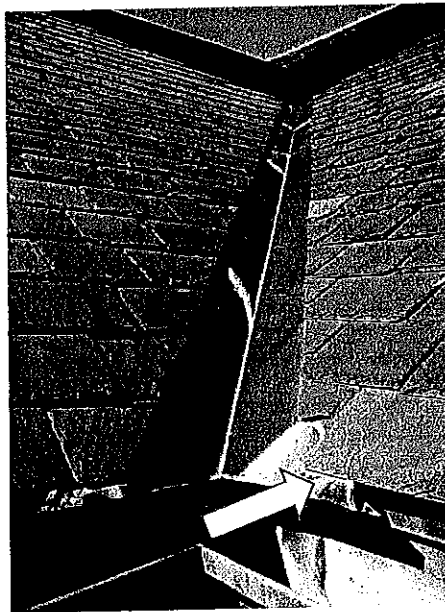
105. Photo 105 – View of a significant number of either missing or damaged pad style snow guards along the eave of the North elevation roof. Also note the amount of slate debris and broken snow guards in the gutter.

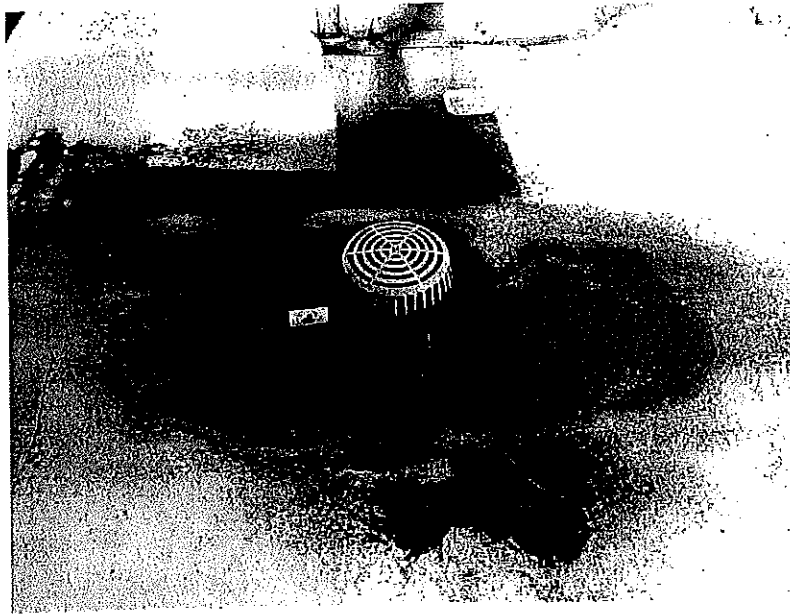
111. Photo 111 – View of the debris and organic growth on the Annex high roof between a parapet and a roof top unit curb.

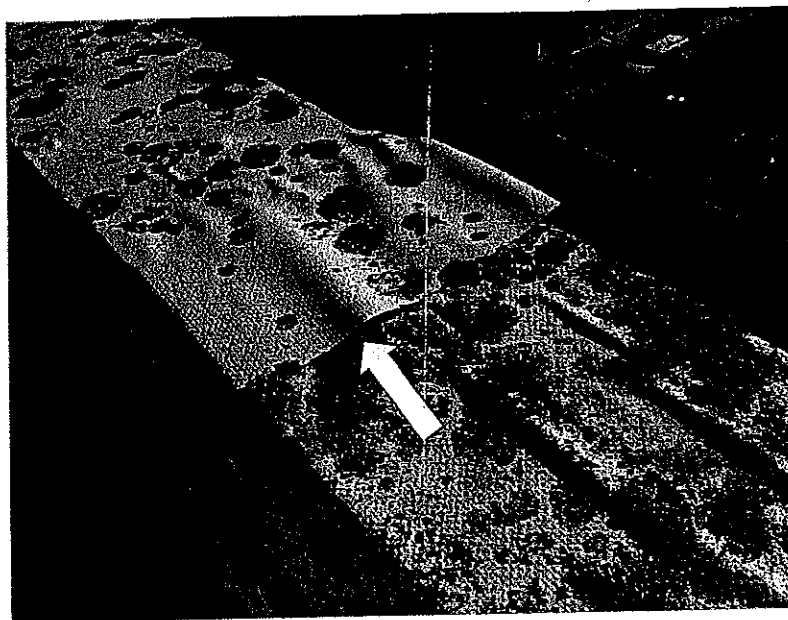
112. Photo 112 – View of debris and ponded water around a roof drain on the high roof.

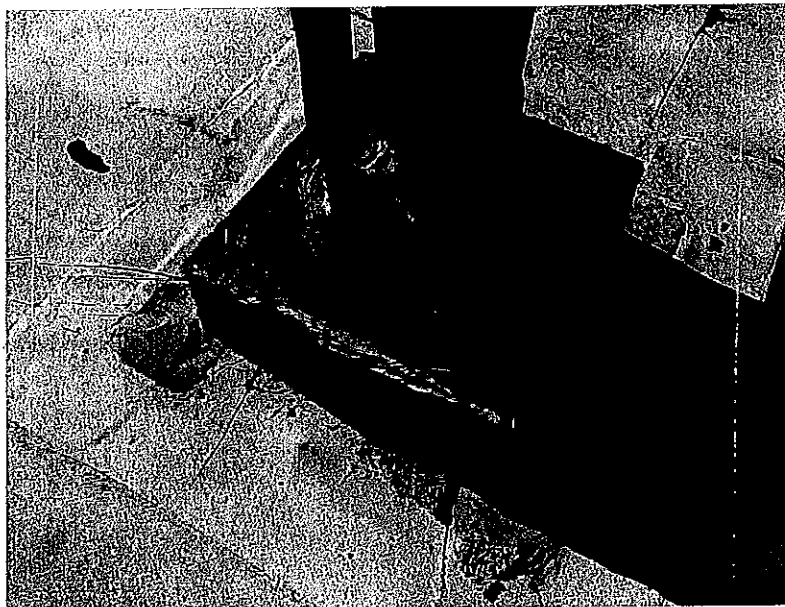
114. Photo 114a and 114b – Views of the deteriorated walkway pads on the Annex high roof.

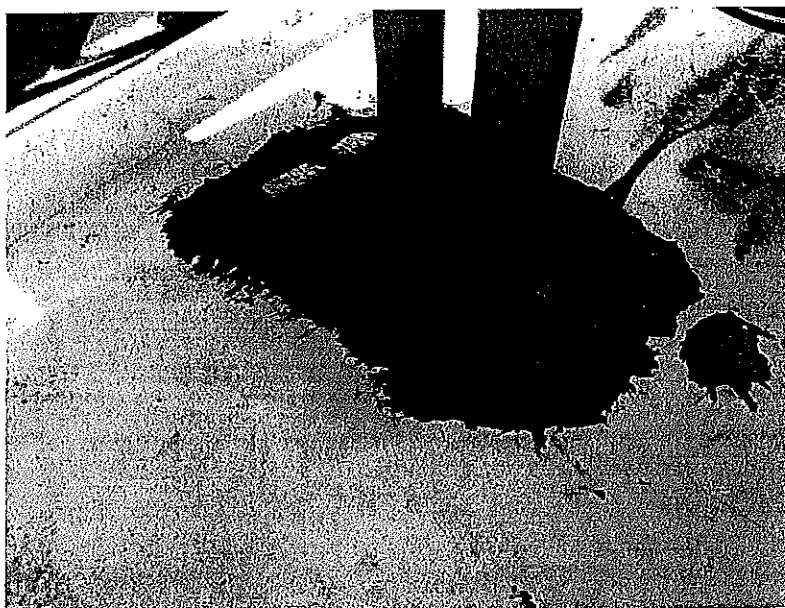
115. Photo 115 – View of the large pitch pocket on the high roof that has cracks within the pourable sealer.

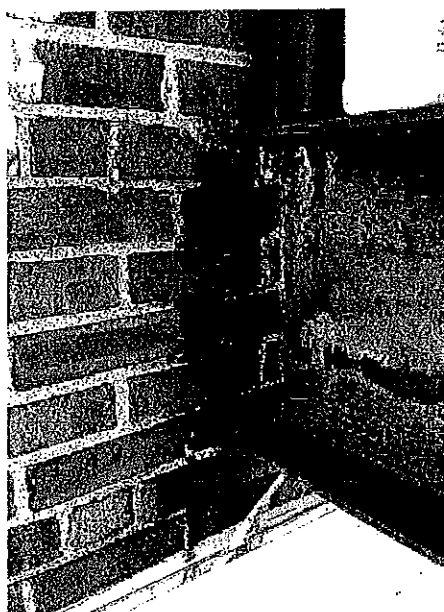
119. Photo 119 – View of the rusted steel dunnage at the Annex low roof and the membrane wrapped parapets. There is evidence of section loss on the steel dunnage.

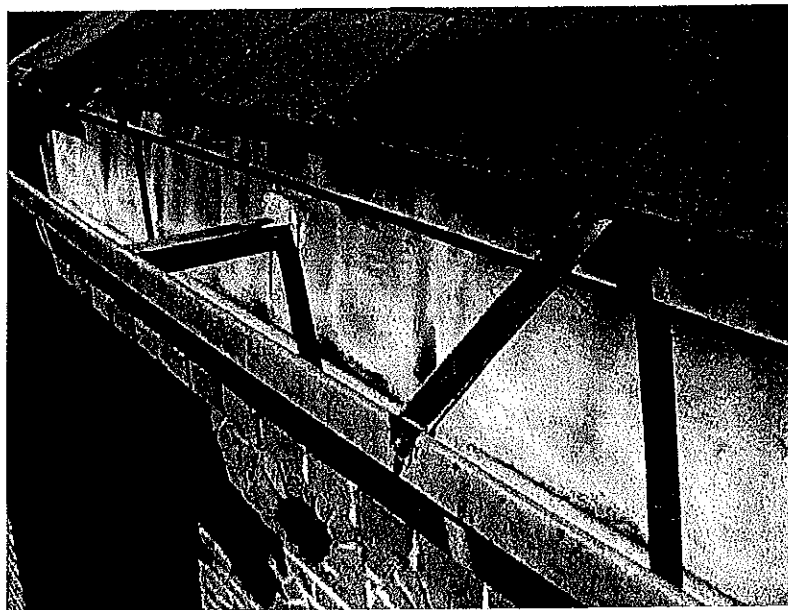
121. Photo 121 – View of the membrane mastic that remains on the rising brick wall on the South Annex elevation above the low roof.

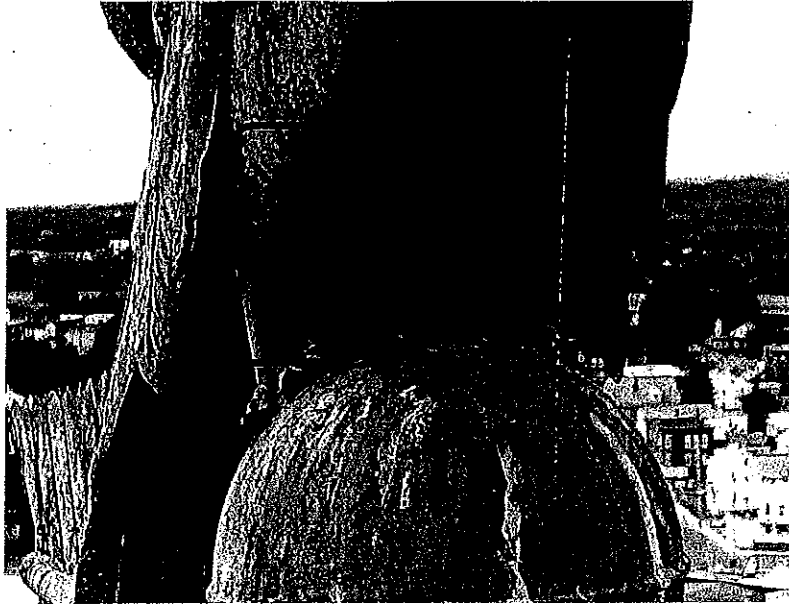
128. Photo 128 – View of the eagle head. The right eye has a crack in the bronze material.
